### CITY OF HOUSTON BUILDING SERVICES DEPARTMENT

THEATER DISTRICT PARKING –  
STRUCTURAL ASSESSMENT  
AND REPAIRS DRAWINGS FOR  
BIDDING AND CONSTRUCTION  
**DETAILS**

FILE NO. C62164
WBS NO. B-000087-0002-4
DRAWING SCALE
VERT. AS SHOWN HORIZ. AS SHOWN
CITY OF HOUSTON PM
JAMES REDDINGTON, JR.
SHEET NO. <b>19</b> OF <b>20</b>

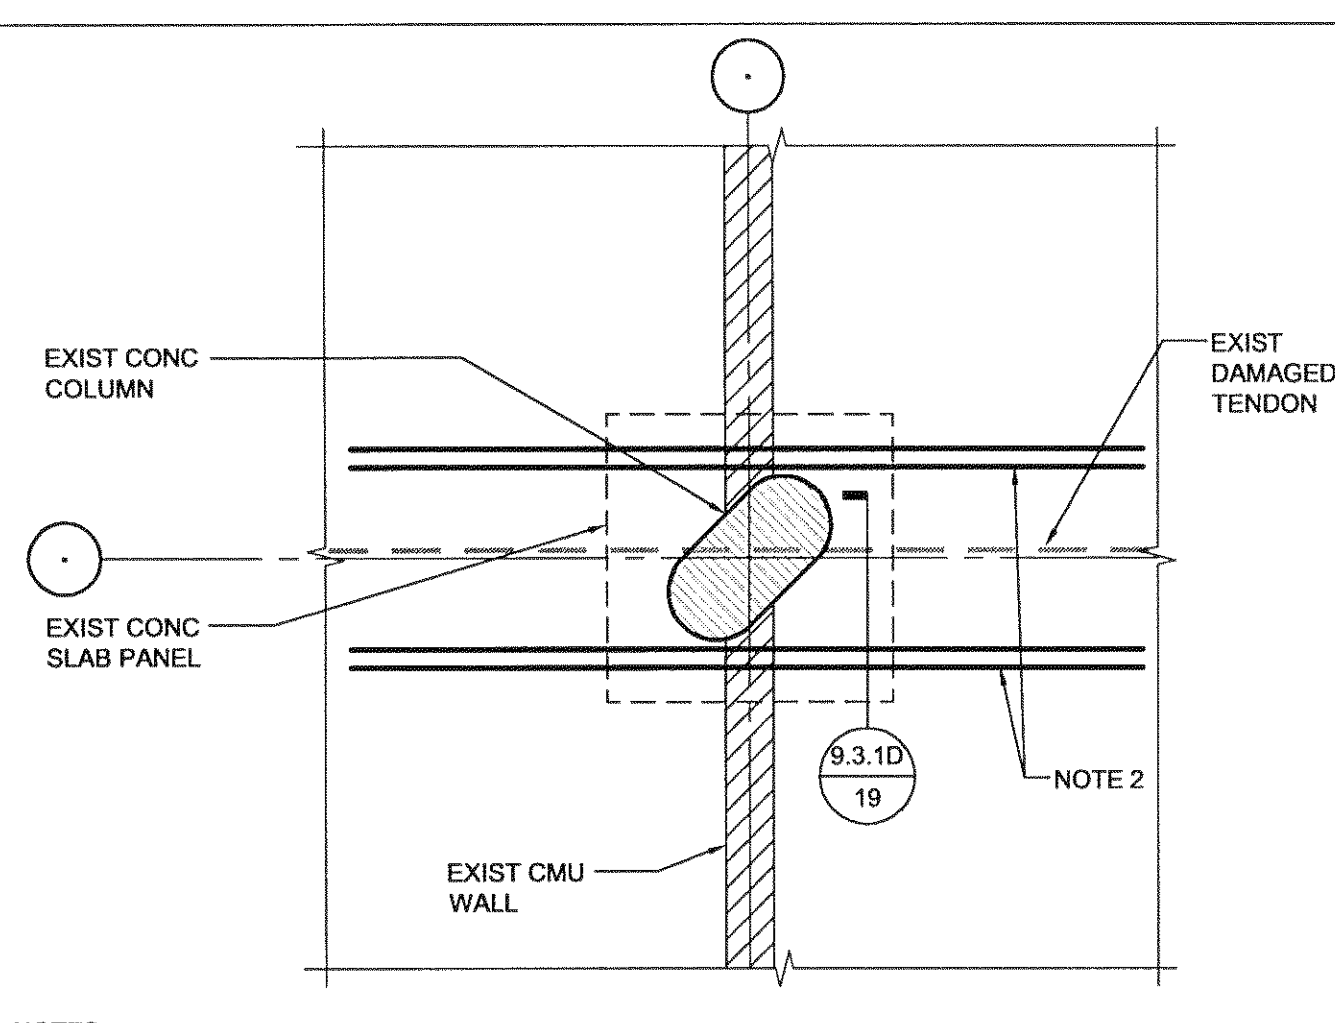
9.3F.1  
NTS

- NOTES:
1. DAMAGED TENDON IS ASSUMED TO BE CORRODED/BROKEN AT ANY HIGH POINT ALONG THE POST-TENSION TENDON.
  2. REFER TO DETAIL 9.3D FOR NSM BAR LAYOUT AND REPAIR.

### REPAIR CONDITION - ORTHOGONAL CORRODED/BROKEN TENDON THROUGH COLUMN AT CMU WALL

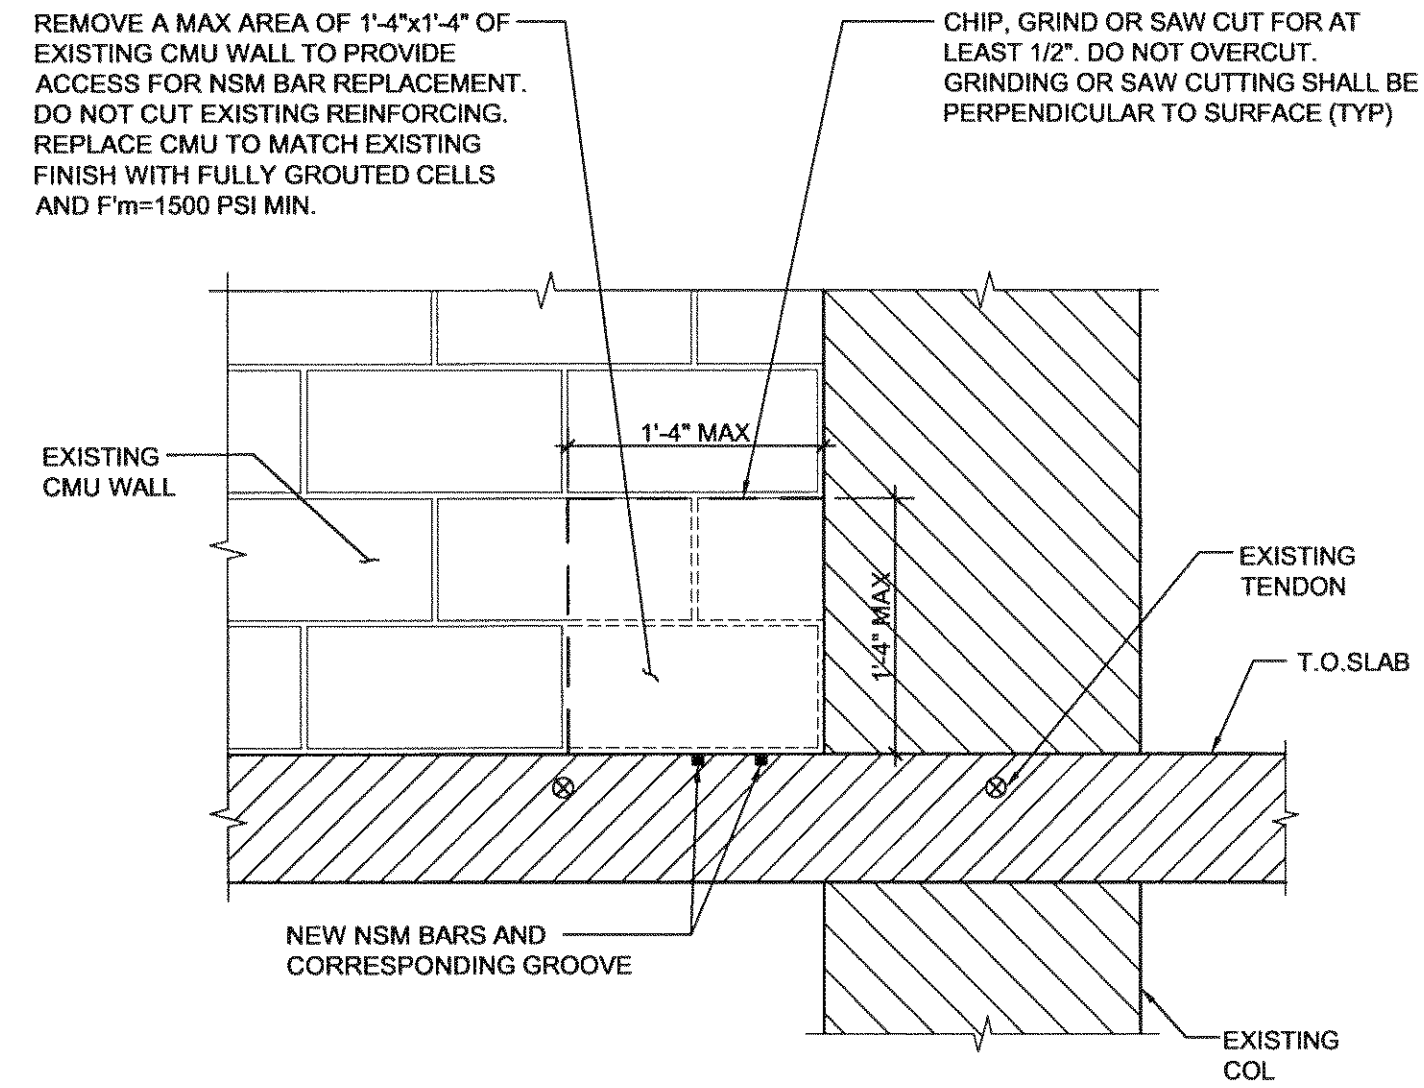
9.3.1D  
NTS

### REMOVAL AND REPLACEMENT OF EXISTING CMU WALL AT NSM BAR PLACEMENT

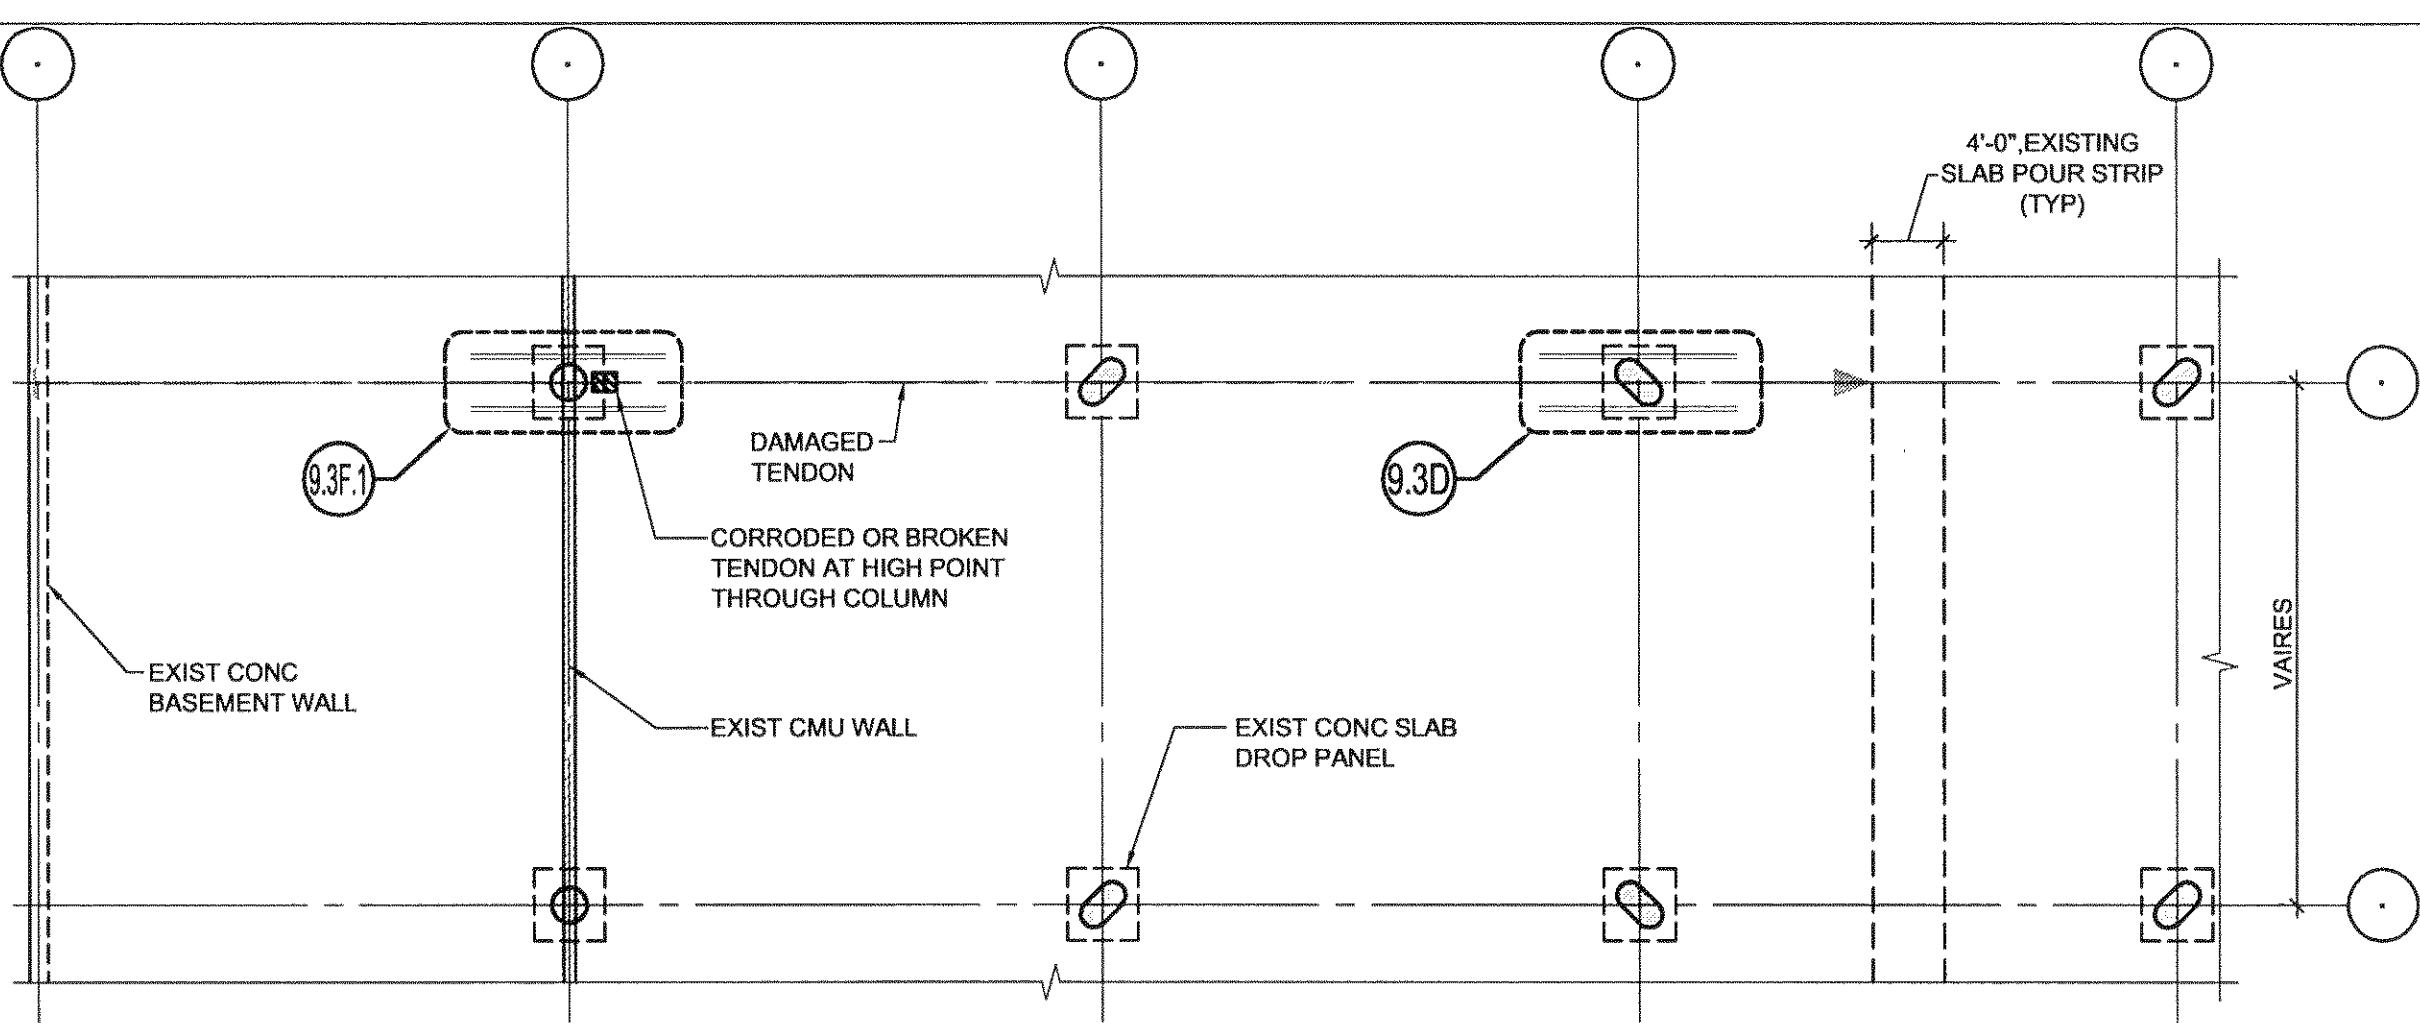
9.3F  
NTS

- NOTES:
1. USE THIS DETAIL WHEN A CORRODED/BROKEN PT TENDON IS LOCATED ON AN INTERIOR COLUMN ADJACENT TO BASEMENT WALL AND EXISTING POUR STRIP.
  2. CFRP NSM BARS TO BE LOCATED PER PLAN LAYOUT SHOWN HERE.

### REPAIR CONDITIONS - INTERIOR COLUMN CORRODED/BROKEN TENDON AT CMU WALL

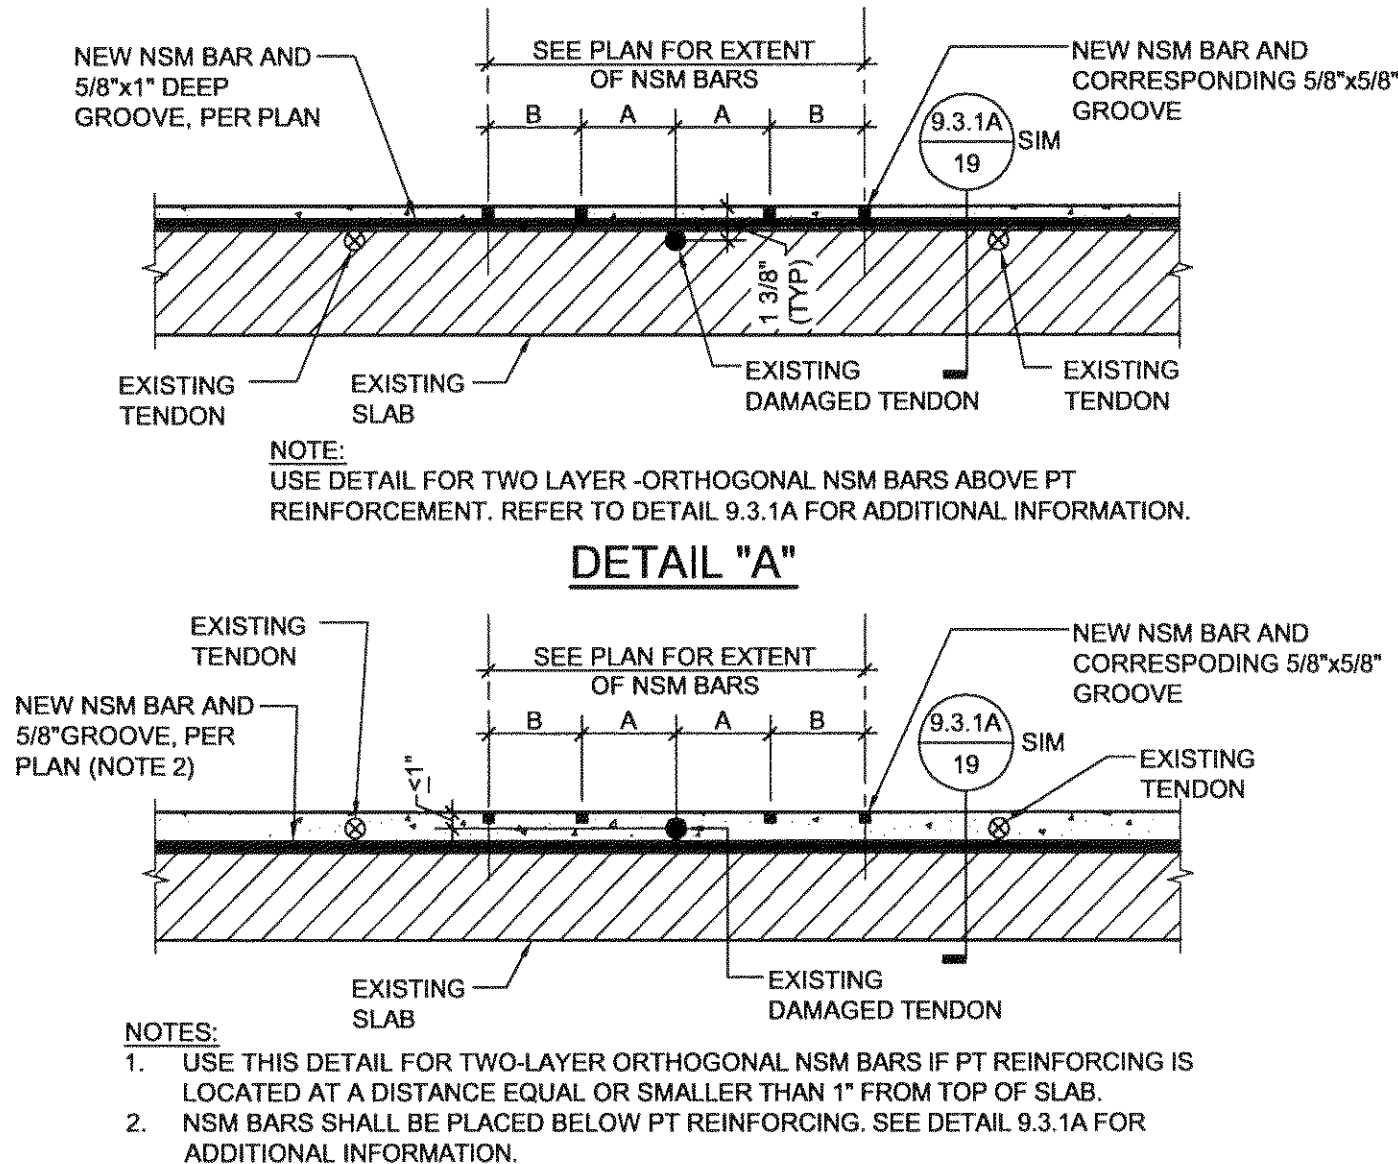
9.3.1C  
NTS

- NOTES:
1. USE THIS DETAIL FOR TWO-LAYER ORTHOGONAL NSM BARS IF PT REINFORCING IS LOCATED AT A DISTANCE EQUAL OR SMALLER THAN 1" FROM TOP OF SLAB.
  2. NSM BARS SHALL BE PLACED BELOW PT REINFORCING. SEE DETAIL 9.3.1A FOR ADDITIONAL INFORMATION.

### 9.3.1C INTERCEPTING NSM BARS AT TOP OF SLAB

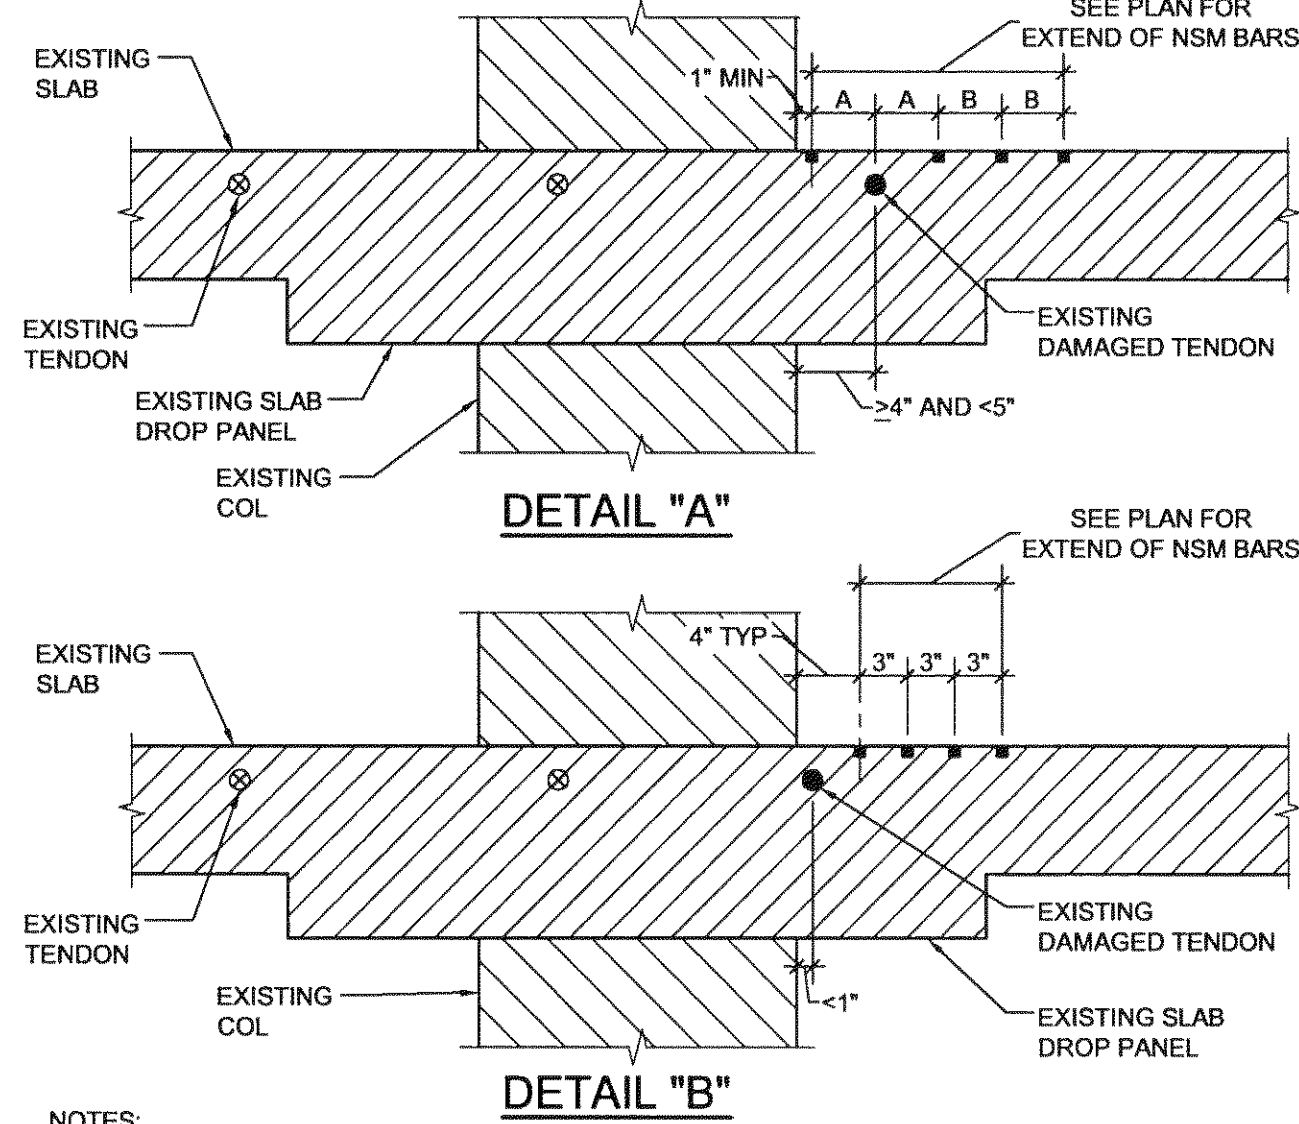
9.3.1B  
NTS

- NOTES:
1. SEE DETAIL 9.3.1A FOR ADDITIONAL INFORMATION.
  2. USE DETAIL 9.3.1A AT OTHER CONDITIONS WHERE DAMAGED TENDON IS LOCATED AT A DISTANCE GREATER THAN 5" FROM FACE OF COLUMN.

### 9.3.1B NSM BARS AT TOP OF SLAB NEAR COLUMN

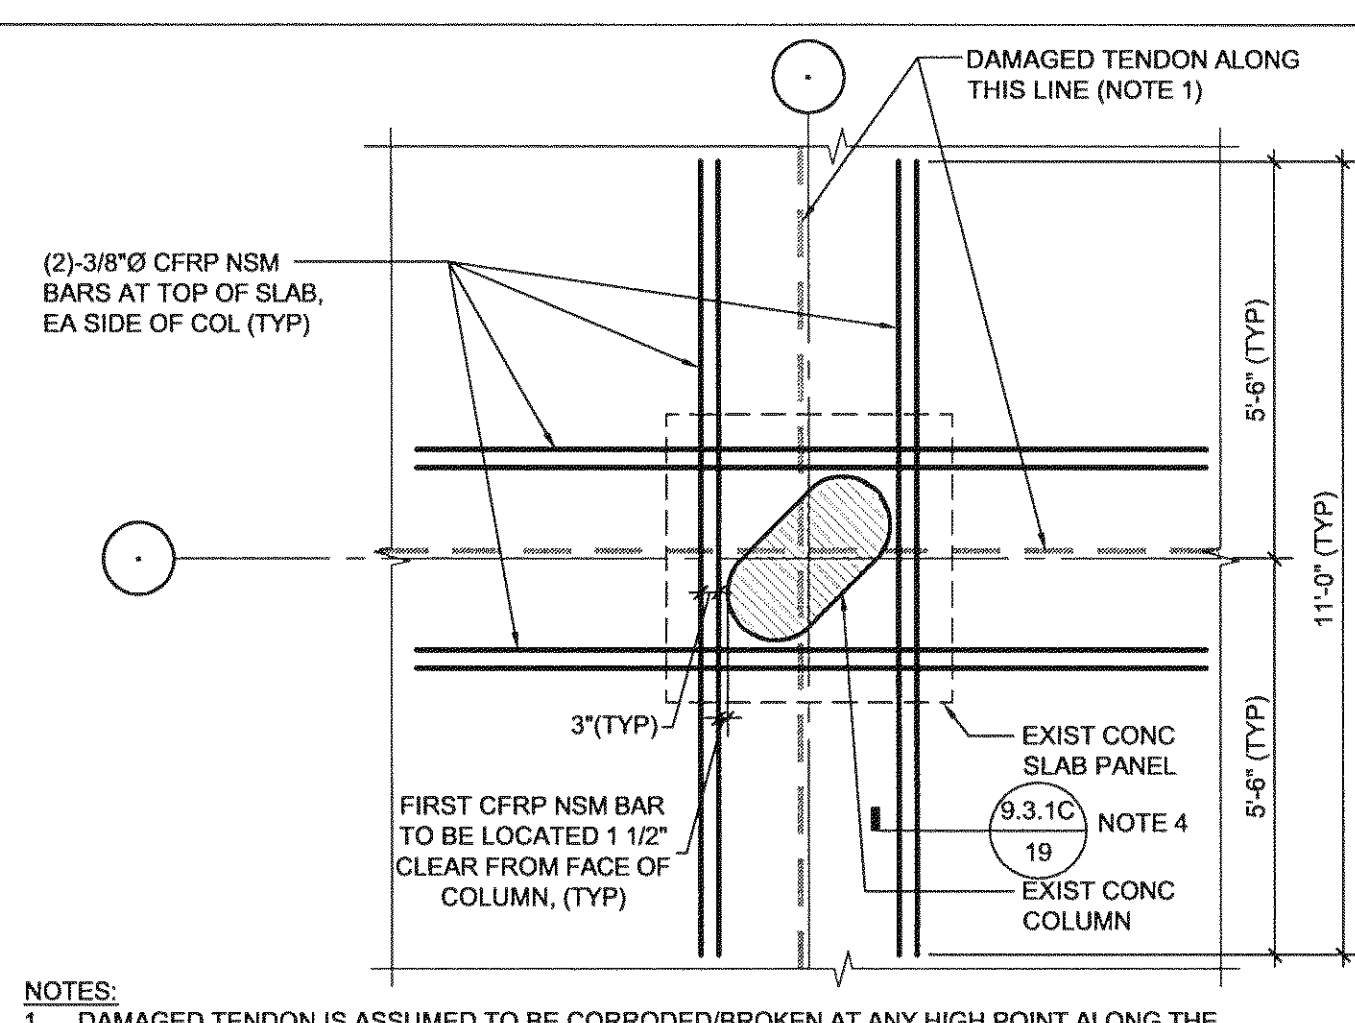
9.3E  
NTS

- NOTES:
1. DAMAGED TENDON IS ASSUMED TO BE CORRODED/BROKEN AT ANY HIGH POINT ALONG THE POST-TENSION BUTTON-HEAD TENDON.
  2. DETAIL INDICATES THE NSM STRENGTHENING REPAIR LAYOUT FOR DAMAGED TENDONS AT A HIGH POINT COLUMN SUPPORT ORTHOGONALLY RUNNING THROUGH COLUMN FOOTPRINT.
  3. DETAIL SHALL BE USED IN CONJUNCTION WITH REPAIR SCENARIOS PER 9.3A, 9.3A.1, 9.3A.2, AND 9.3B ON SHEET 18. FOR ALL ADDITIONAL REPAIR LOCATIONS ALONG THE DAMAGED AT TENDONS IN EACH DIRECTION.
  4. SEE DETAIL 9.3.1C FOR NSM BAR LAYOUT AT INTERCEPTING REINFORCEMENT CONDITIONS.

### REPAIR CONDITION - ORTHOGONAL CORRODED/BROKEN TENDON THROUGH COLUMN

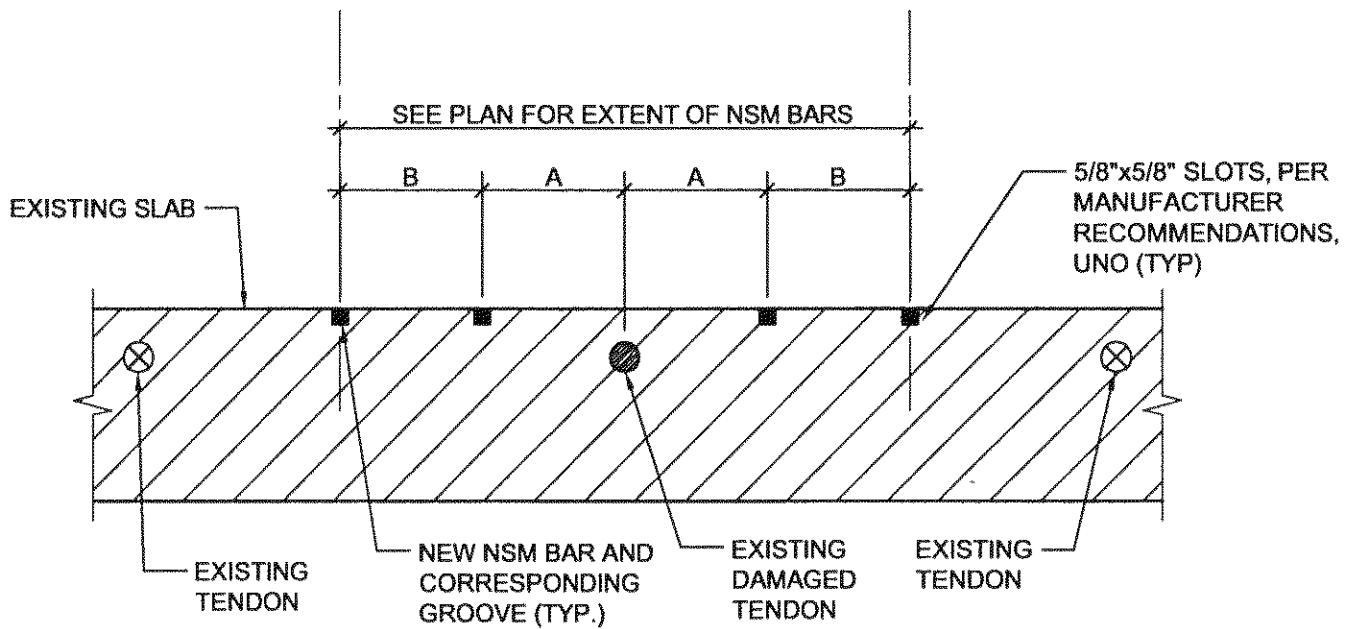
9.3.1A  
NTS

- NOTES:
1. SEE GENERAL NOTES AND SPECIFICATIONS FOR ADDITIONAL INFORMATION.
  2. DO NOT DAMAGE EXISTING TENDONS DURING NSM INSTALLATION.
  3. DO NOT LOCATE NEW NSM BARS DIRECTLY ABOVE TENDON THAT IS PLACED AT THE TOP PORTION OF THE SLAB. KEEP DIMENSION "A" EQUAL TO 3".
  4. SPACING BETWEEN NSM (DIMENSION "B") SHALL BE AT LEAST 2" BUT NO MORE THAN 4".
  5. SEE PLAN FOR ACTUAL NUMBER OF NSM BARS.
  6. CENTER ALL NSM BARS AROUND DAMAGED TENDON UNLESS NOTED OTHERWISE ON DRAWINGS.

### 9.3.1A NSM BARS AT TOP OF SLAB
